**Proposed Redwin Lodge
Lot 619 DP 1118588 Mountain Drive, Thredbo
NSW**

Geotechnical Investigation

Our ref: 4291-1-G1
14 April 2021

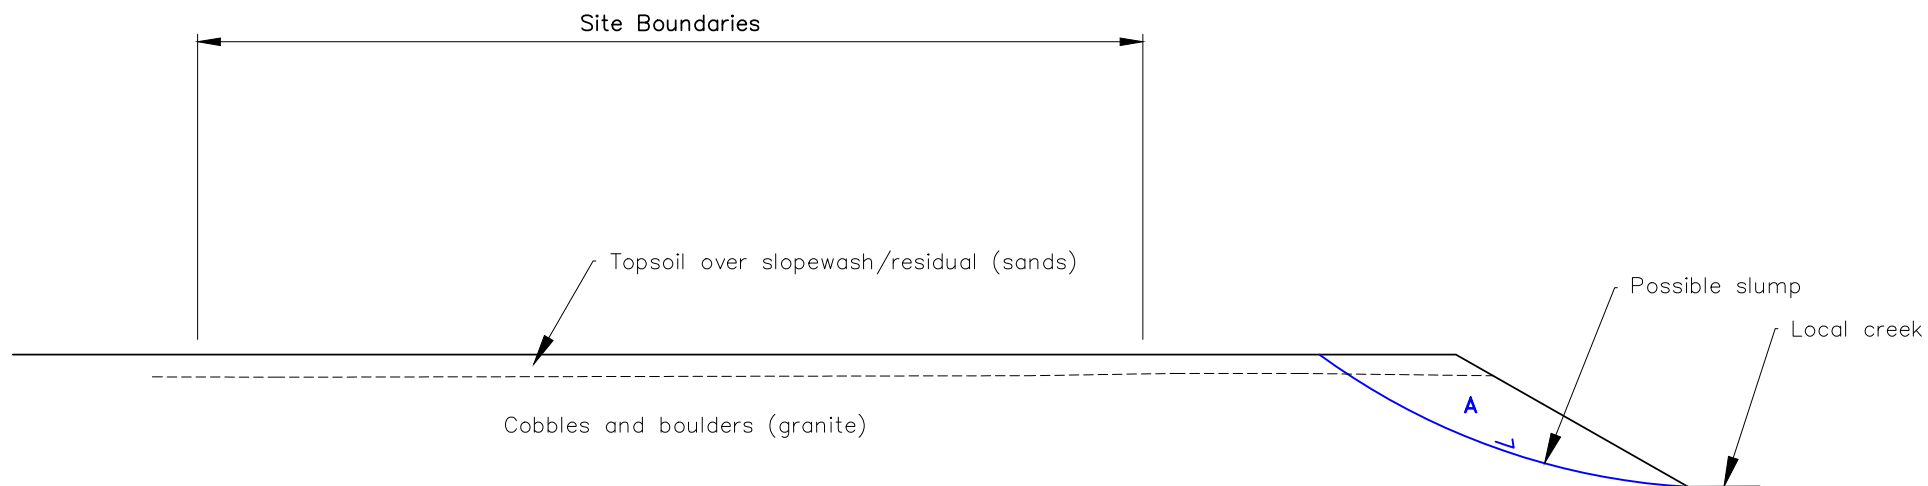
The boreholes and DCP testing, and site observations, indicated a relatively consistent subsurface profile as indicated in Table 1. An interpreted section is provided in Figure 3. For a detailed description of the subsurface conditions, refer the attached engineering logs and explanatory notes. For specific design input, reference should be made to the logs and/or the specific test results, in place of the following summary and the interpreted section.

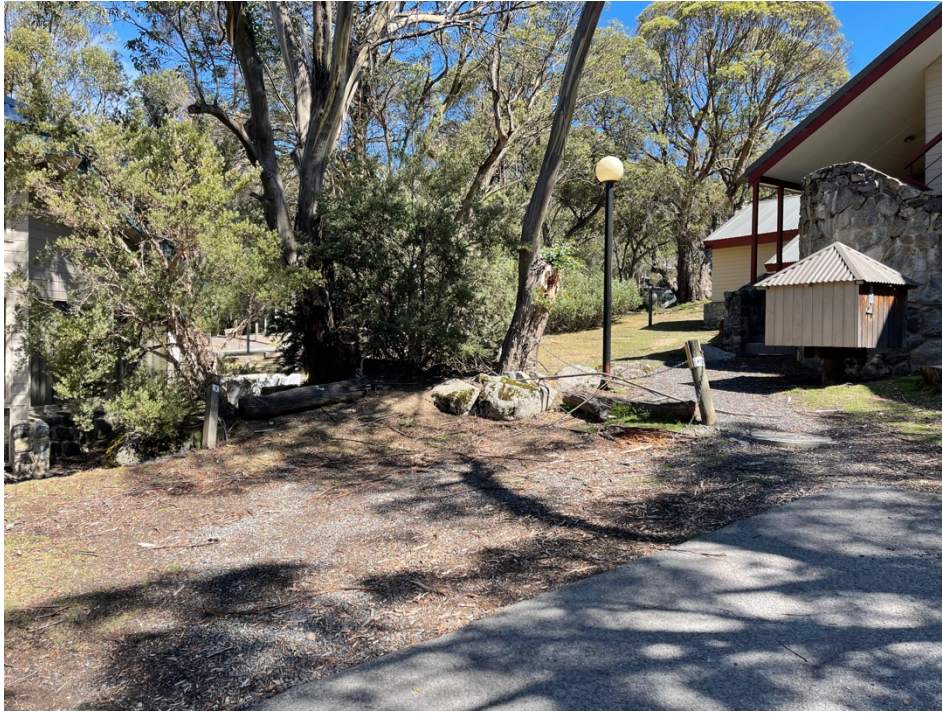
Photo 1
View of front of lodge
from Valley Close,
looking south-west

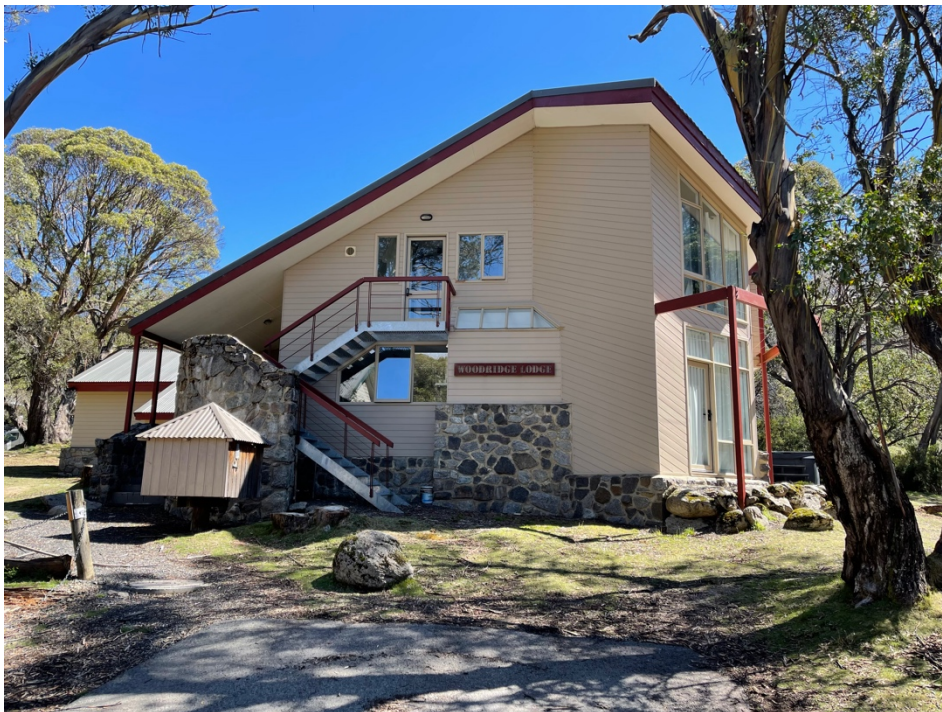
Photo 2
Continuation of
Photo 1, looking west

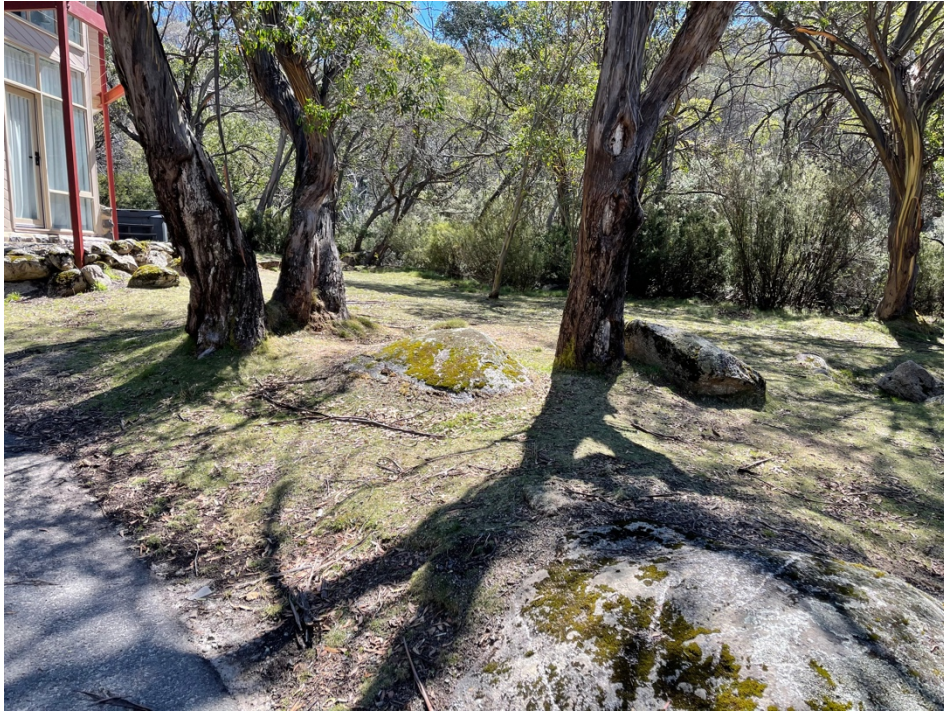
Photo 3
Continuation of
Photo 2, looking
north-west

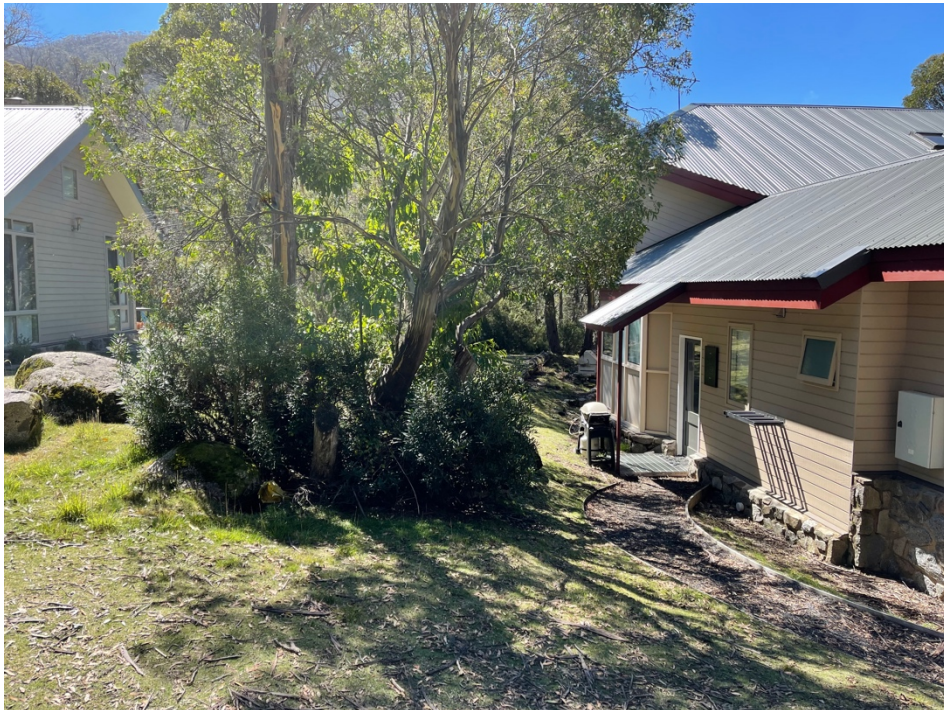
The existing lodge (see Photos 1 to 8) is located at the toe of a moderate slope of about 10 to 20°, and the rear of the lodge has been cut into the slope by about 1m to 1.2m height, supported by an uncemented granite rock wall which was in overall good condition at the time of the inspection. The lodge itself was also observed to be in overall good condition at the time of the inspection.

Photo 4
View of rear of lodge,
looking north/north-
east

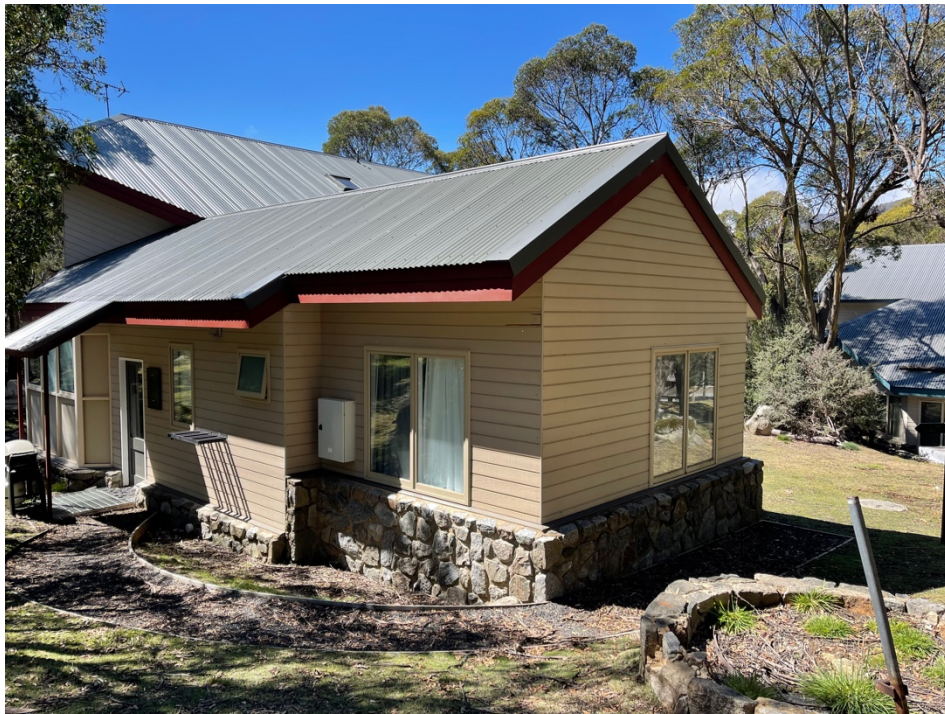
Photo 5
View of rear of lodge,
looking north-east

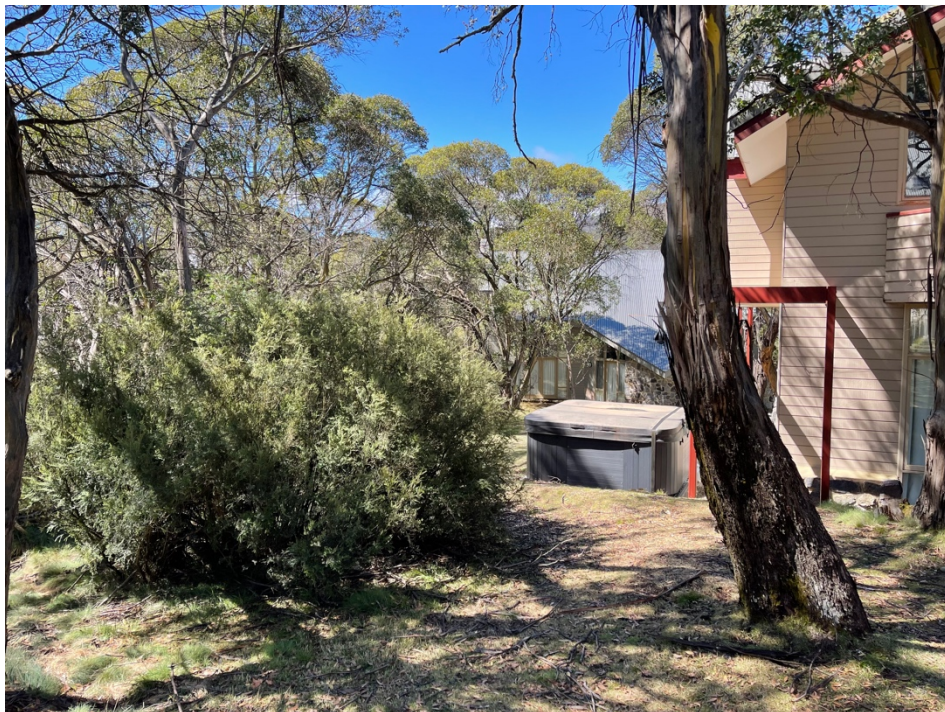
Photo 6
View of rear of lodge
showing spa to north,
looking east. Creek
located to north (left)
of site

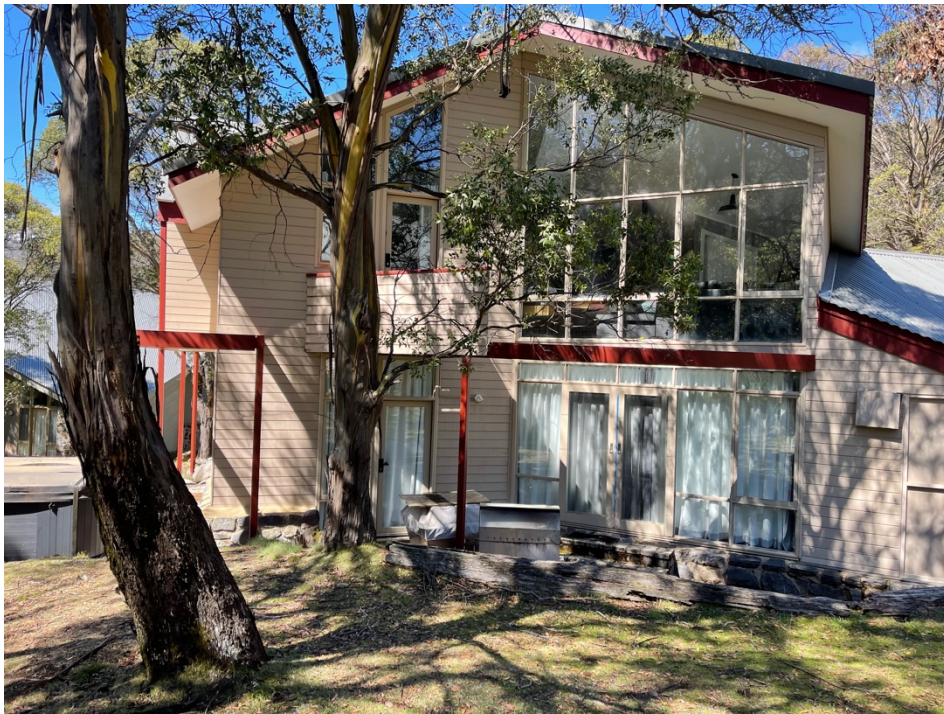
Photo 7
View of rear of lodge
looking east
(continuation of
Photo 6)

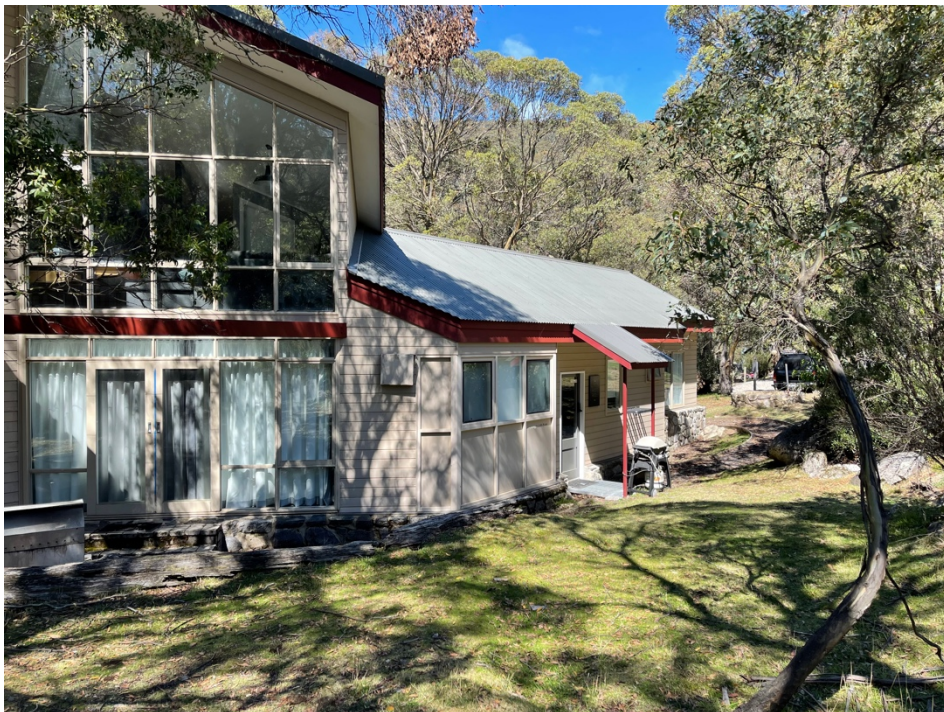
Photo 8
View of rear of lodge
looking south-east
(continuation of
Photo 7)

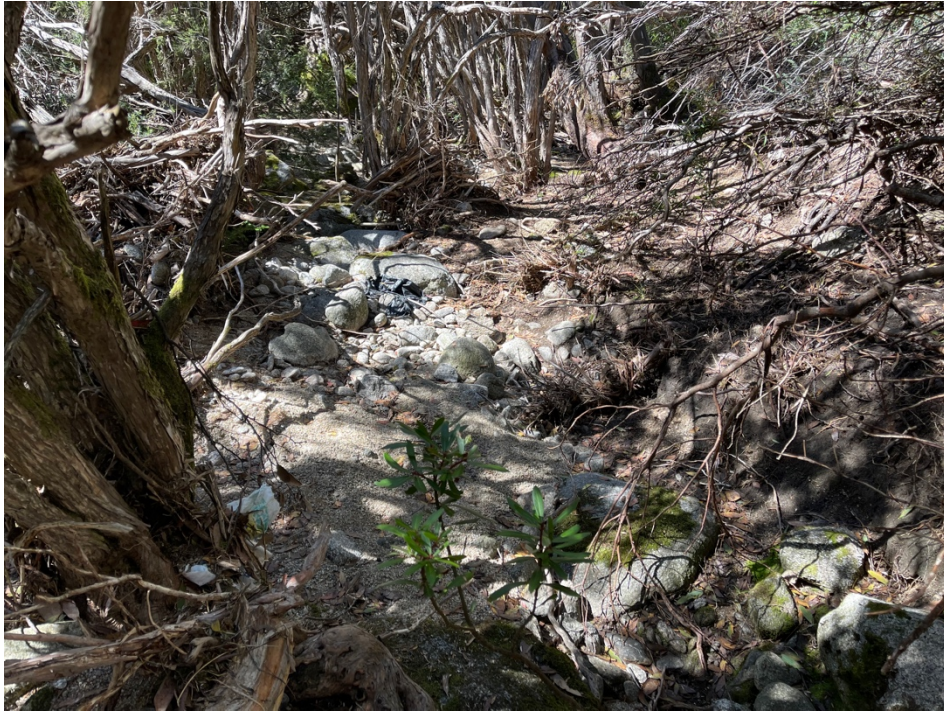
Groundwater conditions are unknown, but it is expected that intermittent groundwater would be present within the soils overlying the weathered granite. The local creek to the north of the site was dry at the time of the fieldwork.

Photo 9
View of creek bed to
north of property,
looking south-east

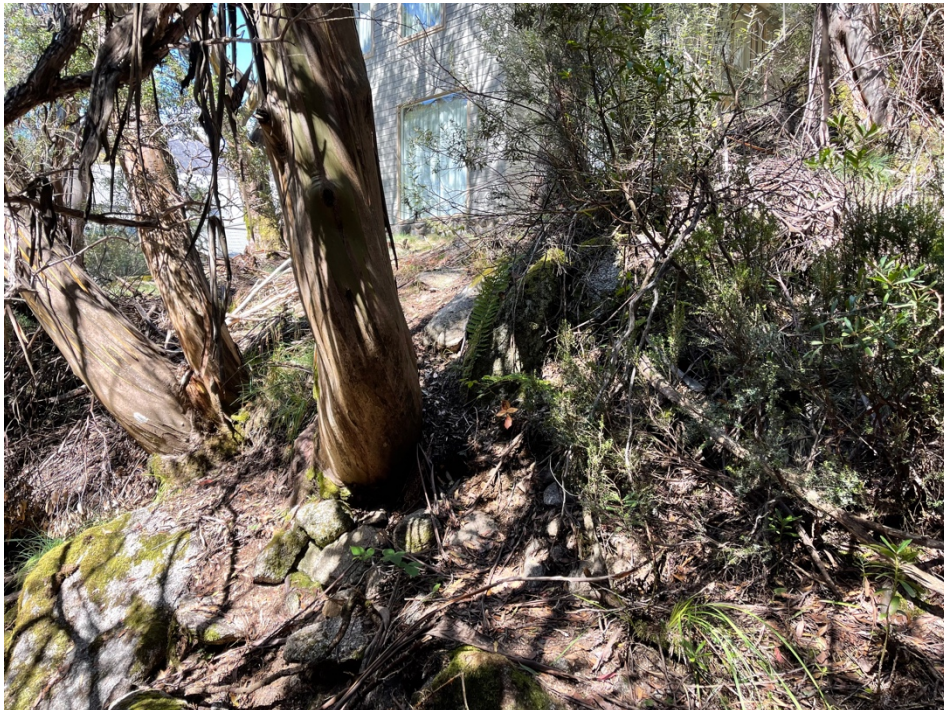
Photo 10
View of creek bank
viewed from base of
creek, existing lodge
shown in
background, looking
approx. south
