**Proposed Woodridge Lodge
Lot 619 DP 1118588 Mountain Drive,
Thredbo NSW**

Geotechnical Investigation

Our ref: 4291-1-G1 Rev 1
3 November 2021

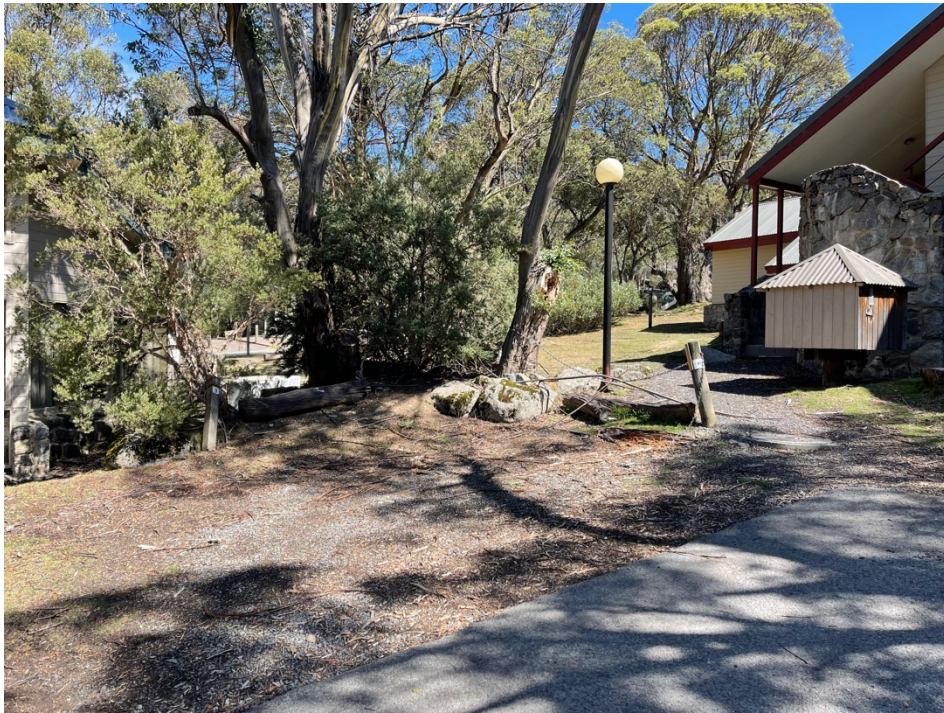
The existing lodge (see Photos 1 to 8) is located at the toe of a moderate slope of about 10 to 20°, and the rear of the lodge has been cut into the slope by about 1m to 1.2m height, supported by an uncemented granite rock wall which was in overall good condition at the time of the inspection. The lodge itself was also observed to be in overall good condition at the time of the inspection.

Photo 1
View of front of lodge
from Valley Close,
looking south-west

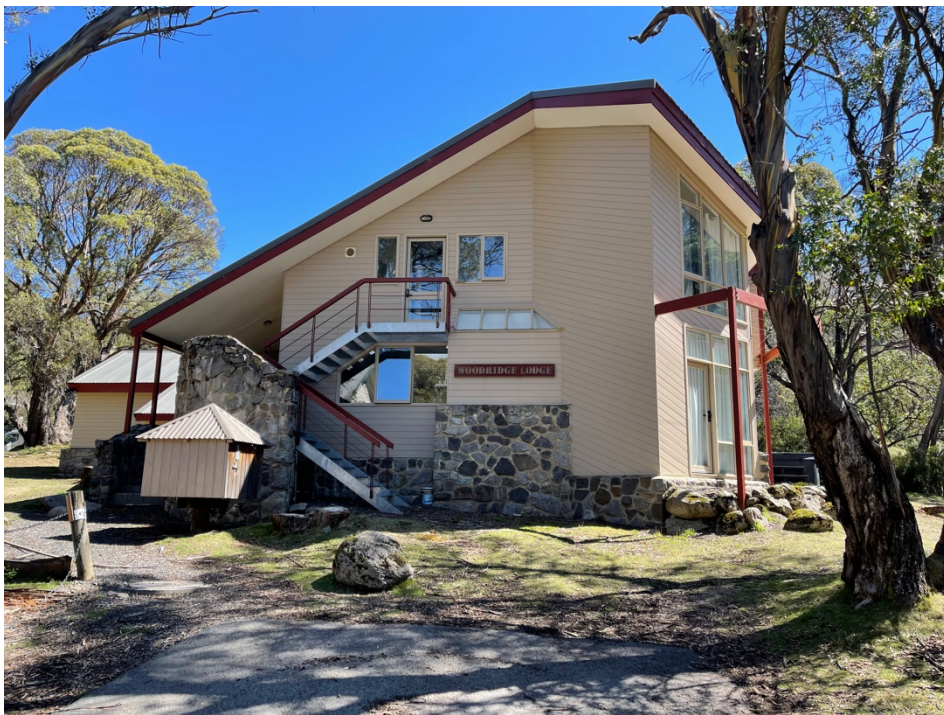
Scattered cobbles and granite boulders are present across the landform (see Photos 2 and 3), and in the banks of local creek to the north of the site (see Photos 9 and 10).

Photo 2
Continuation of
Photo 1, looking west

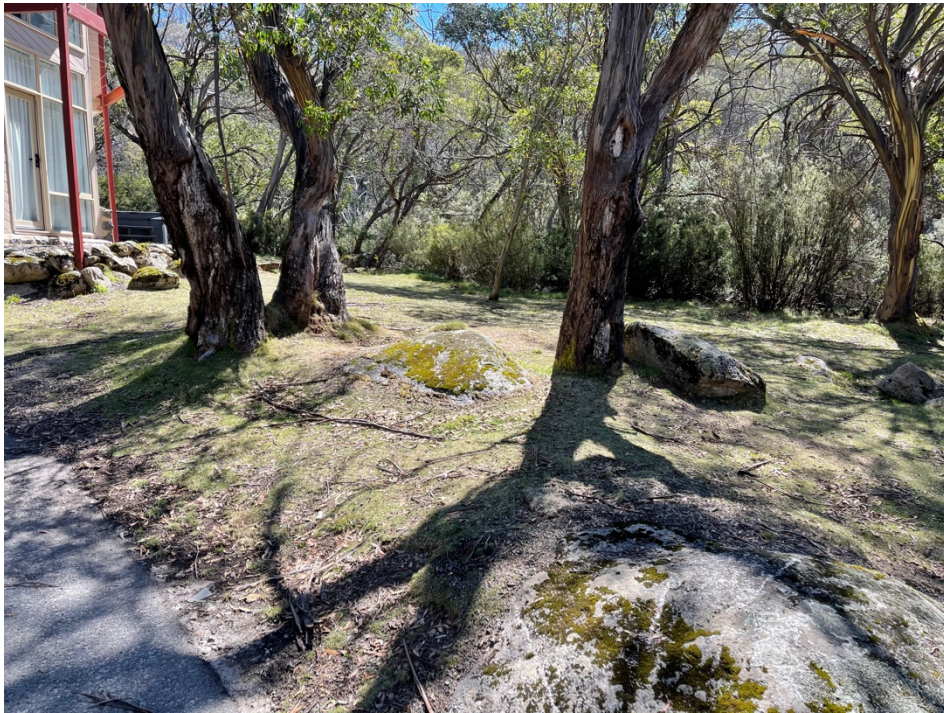
Photo 3
Continuation of
Photo 2, looking
north-west

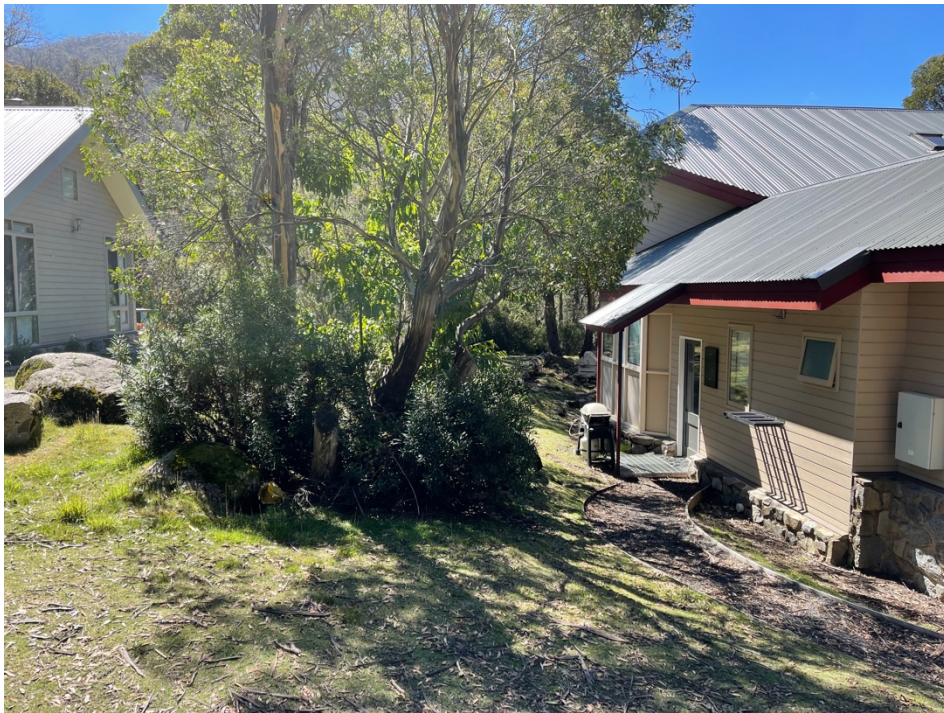
Photo 4
View of rear of lodge,
looking north/north-
east

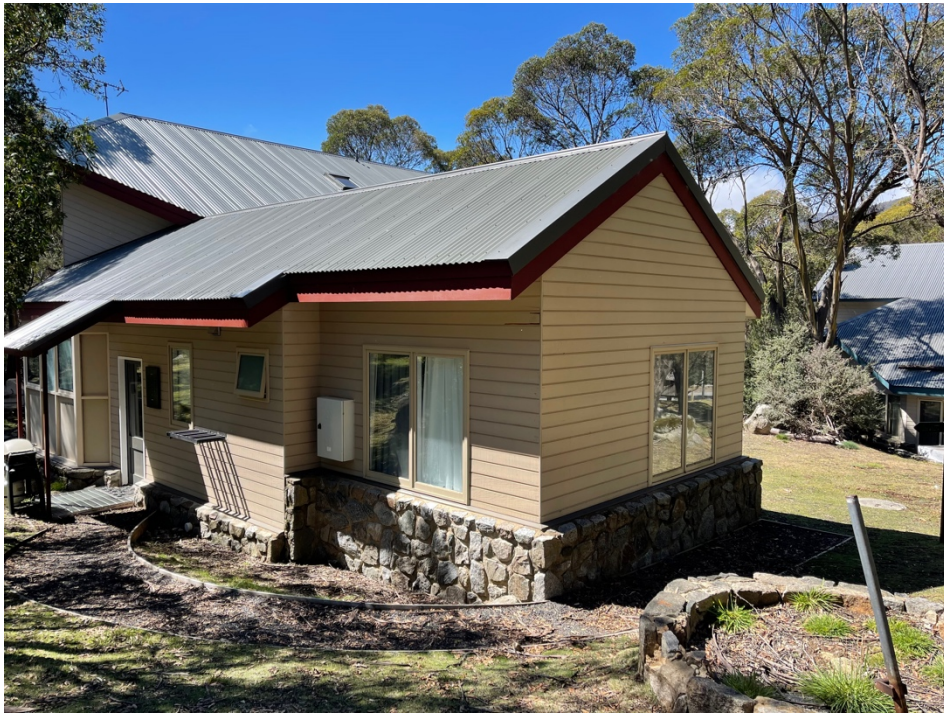
Photo 5
View of rear of lodge,
looking north-east

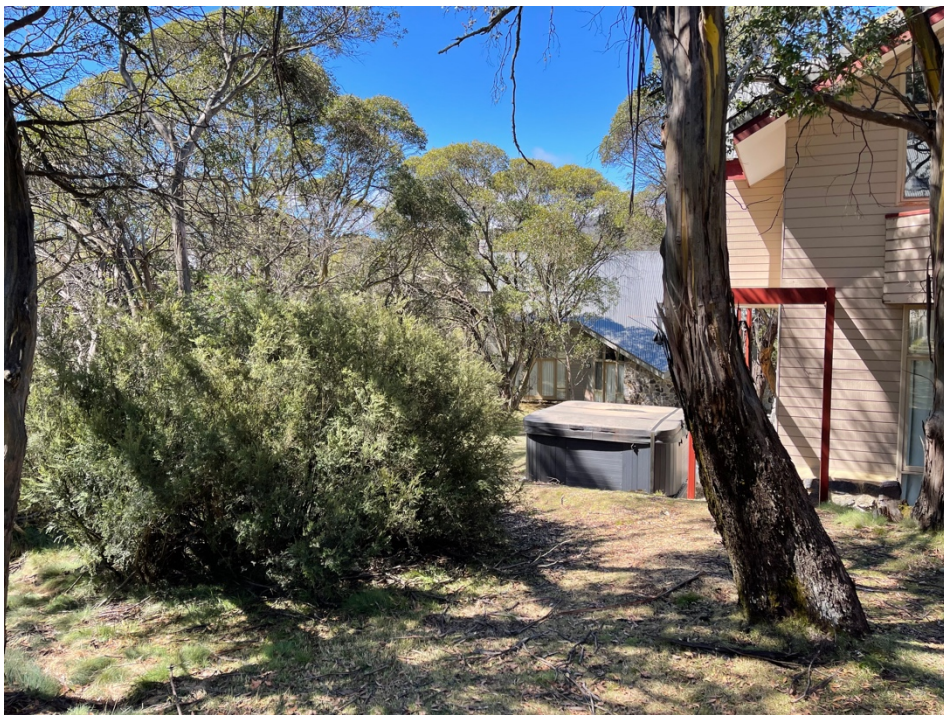
Photo 6
View of rear of lodge
showing spa to north,
looking east. Creek
located to north (left)
of site

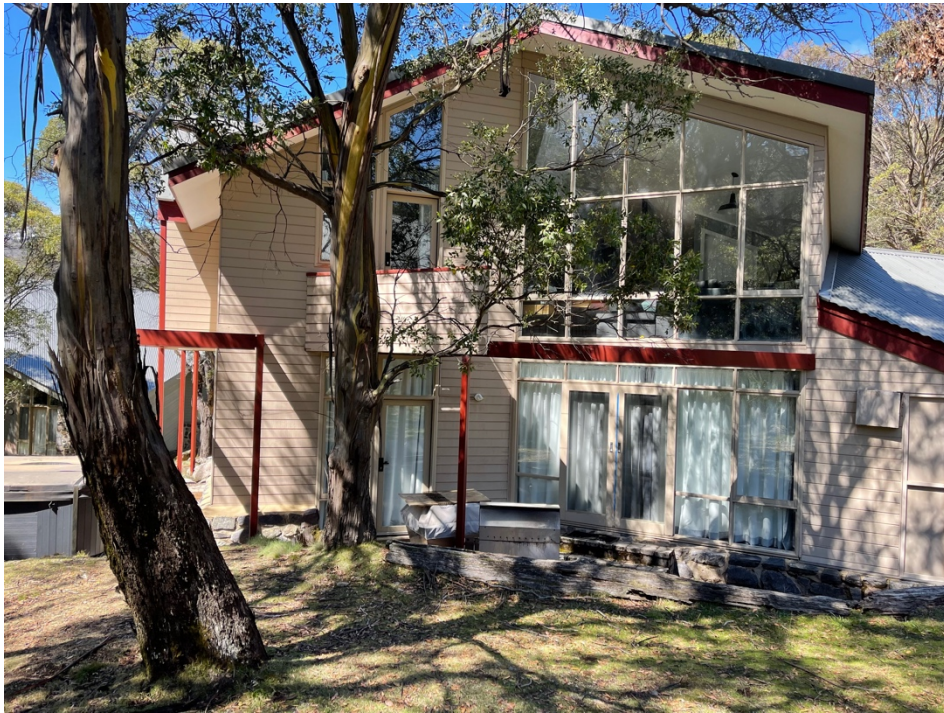
Photo 7
View of rear of lodge
looking east
(continuation of
Photo 6)

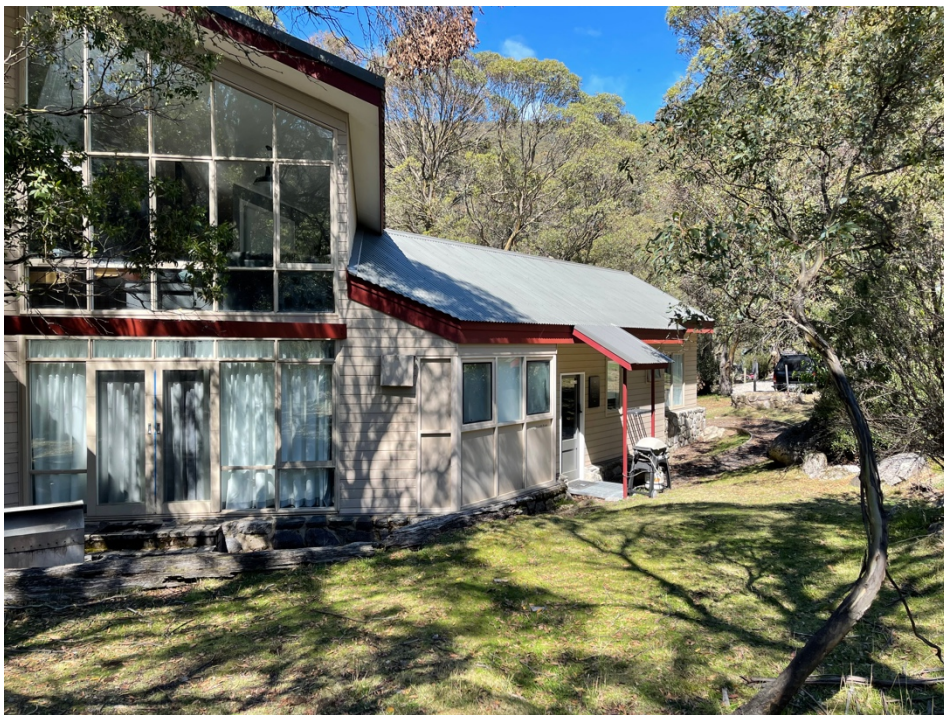
Photo 8
View of rear of lodge
looking south-east
(continuation of
Photo 7)

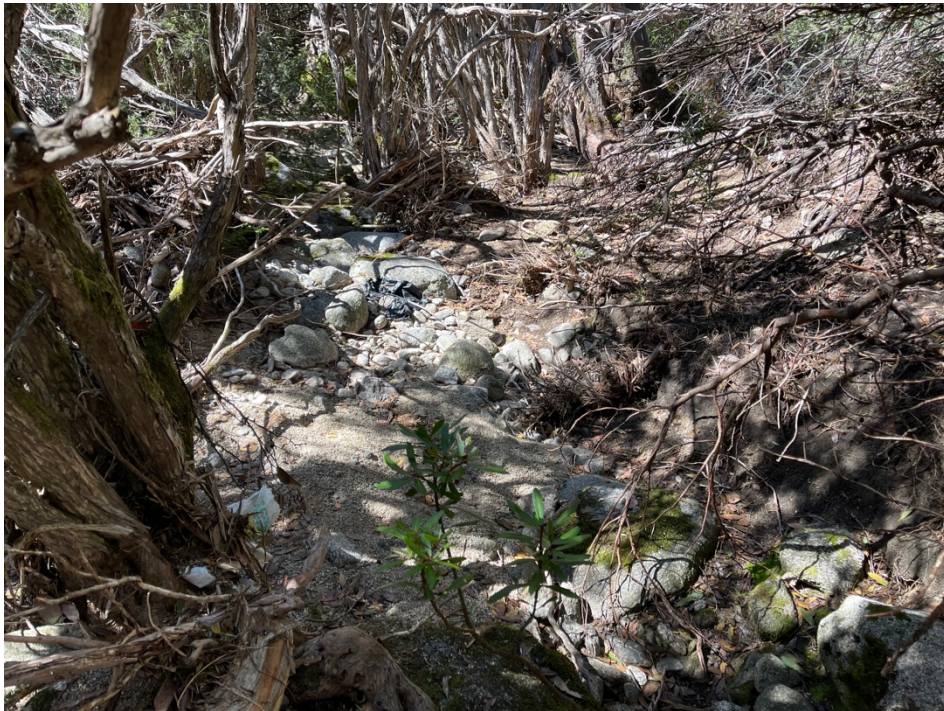
Photo 9
View of creek bed to north of property, looking south-east

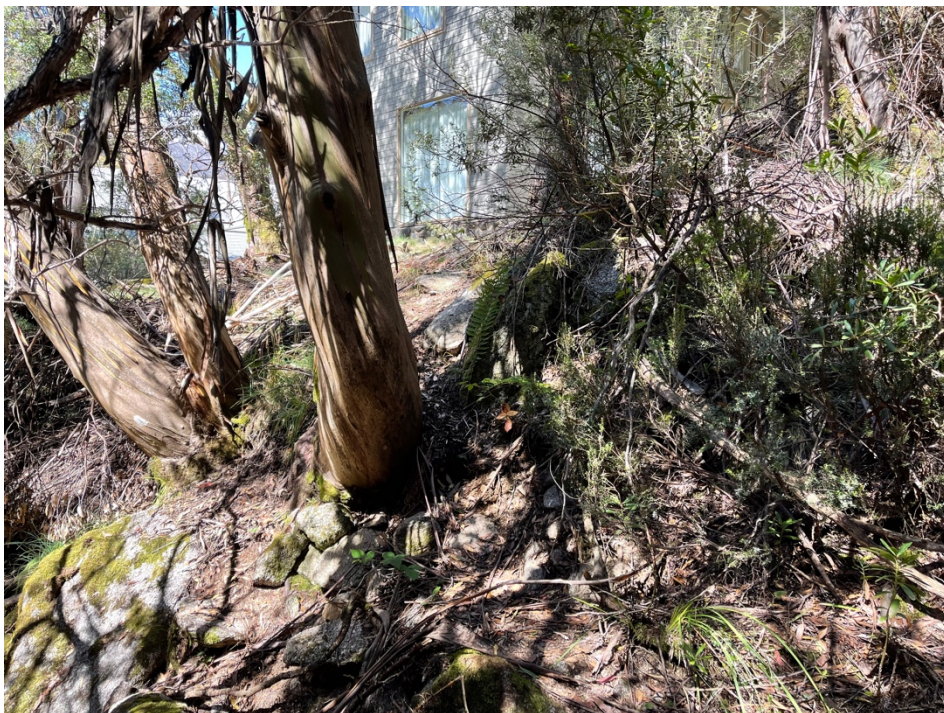
Photo 10
View of creek bank viewed from base of creek, existing lodge shown in background, looking approx. south
